RECAPP Facility Evaluation Report

Lorne Akins Junior High School

B4072A

Evaluation Company: Kenneth M. Lee Architect
Evaluation Date: October 17 2008
Evaluator Name: Ken Lee

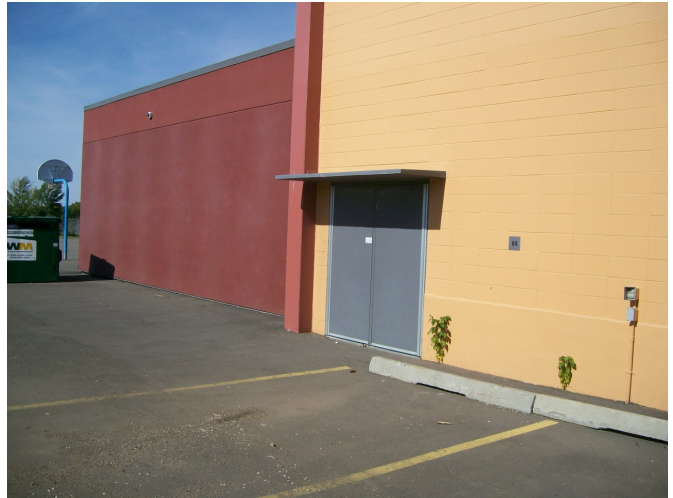
Precast concrete canopies for the gymnasium exterior door and the window of industrial arts classroom. The main entrance area is under the cantilever portion of second floor. The construction is metal stud frame on steel joists.

<u>Rating</u>	<u>Installed</u>	<u>Design Life</u>	<u>Updated</u>
4 - Acceptable	1963	0	MAR-09

The precast concrete canopy for the gymnasium exterior door.:

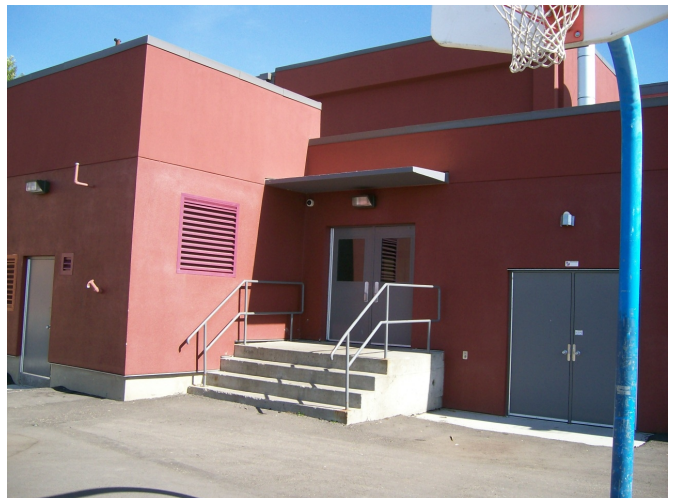
B1020.04 Canopies - 2006 Section

Precast concrete canopy.

<u>Rating</u>	<u>Installed</u>	<u>Design Life</u>	<u>Updated</u>
5 - Good	2006	0	MAR-09

The precast concrete canopy and concrete stair.

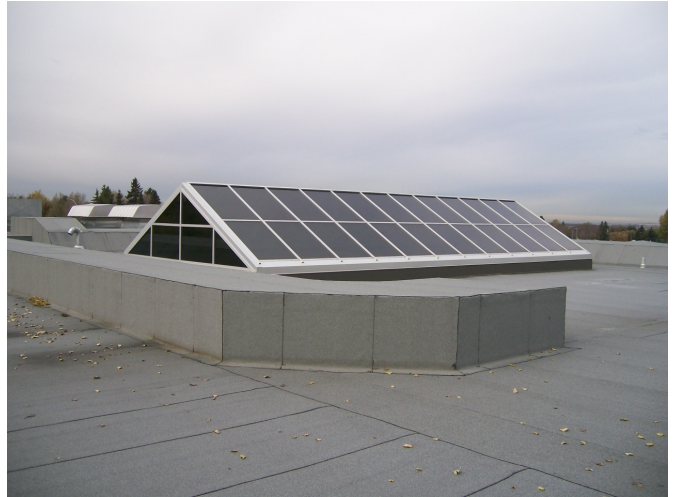
One aluminum frame ridge shape skylight installed in the 2006 modernization.

<u>Rating</u>	<u>Installed</u>	<u>Design Life</u>	<u>Updated</u>
5 - Good	2006	25	MAR-09

The exterior of the skylight.

Event: Replace 1 aluminum frame ridge type skylight.
(Approx. 12.50 m. L x 5.60 m. W x 2.00 m. H)

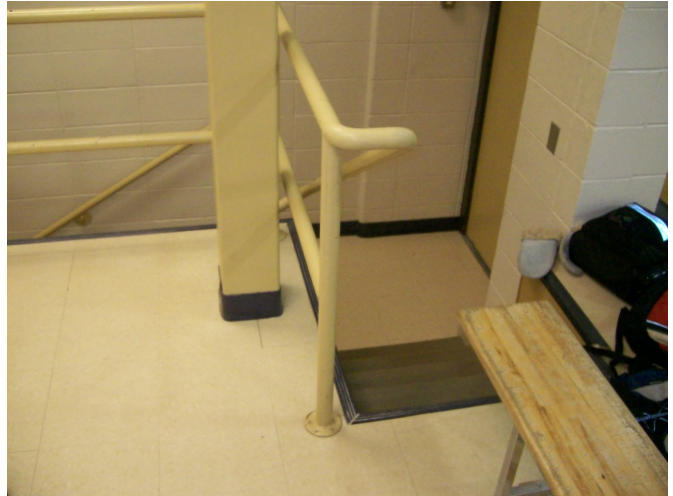
Floor-mounted steel pipe balustrades for the stage at two stairs to the basement with paint finish.
Floor-mounted steel pipe with metal panel balustrade on second floor of the southwest stair.

<u>Rating</u>	<u>Installed</u>	<u>Design Life</u>	<u>Updated</u>
4 - Acceptable	1963	0	MAR-09

The steel pipe balustrades at the stage.

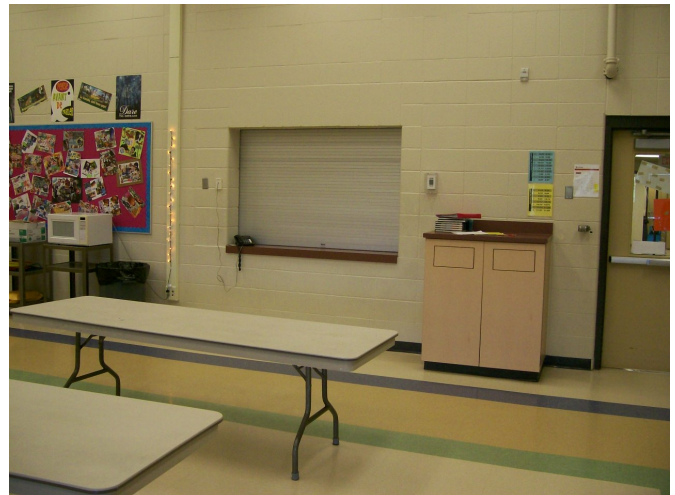
A metal overhead coiling door for the kitchen.

<u>Rating</u>	<u>Installed</u>	<u>Design Life</u>	<u>Updated</u>
5 - Good	1963	0	MAR-09

The metal overhead coiling door for the kitchen.

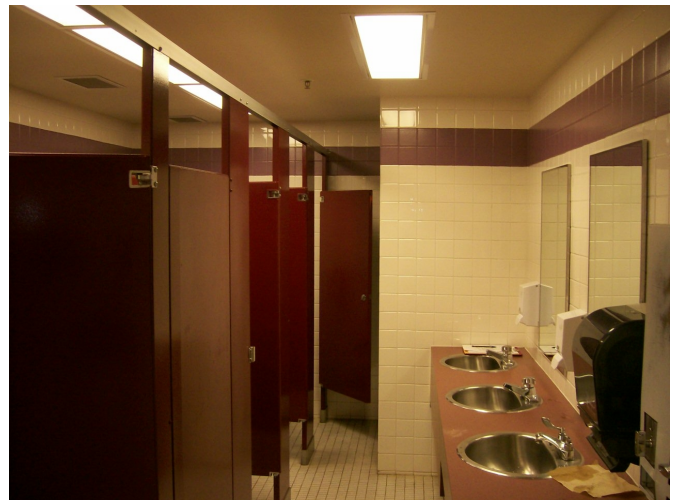
Floor supported metal toilet partitions throughout.

<u>Rating</u>	<u>Installed</u>	<u>Design Life</u>	<u>Updated</u>
5 - Good	2006	30	MAR-09

The girl's washroom on main floor.

Event: Replace floor supported metal toilet partitions.

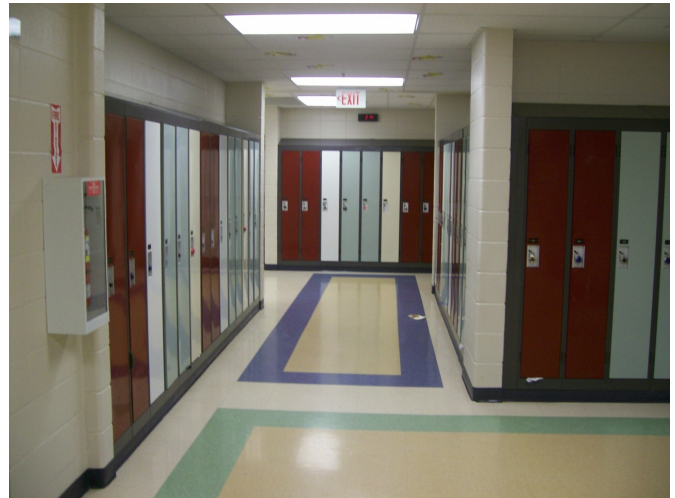
<u>Rating</u>	<u>Installed</u>	<u>Design Life</u>	<u>Updated</u>
5 - Good	2006	30	MAR-09

The single tier metal lockers in a main floor corridor.

Event: Replace metal lockers. (551 single tier, 2 six tier)

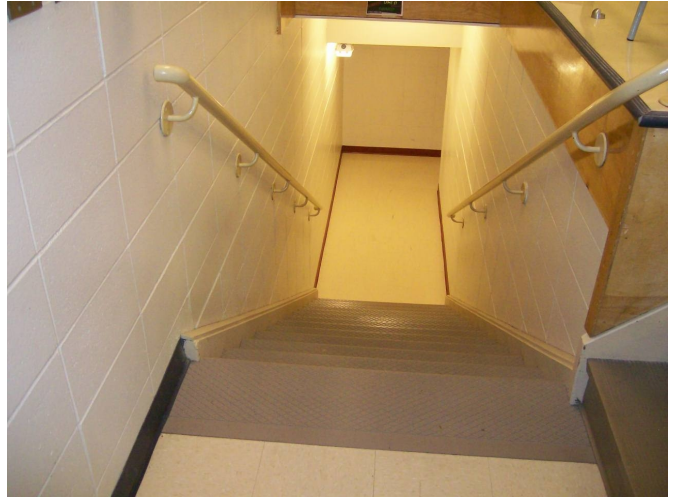
Two wood stairs from main floor to the basement.
 Two wood stairs from gymnasium level to the stage.
 The main stair at the main entrance lobby on main floor to second floor is a concrete stair.
 The stair at the southwest corner of the building (Southwest Stair) from main floor to second floor is a concrete stair.
 The stairs from main floor to the main entrance of the gymnasium is a concrete stair.

<u>Rating</u>	<u>Installed</u>	<u>Design Life</u>	<u>Updated</u>
4 - Acceptable	1963	0	MAR-09

The stair from gymnasium to the basement.

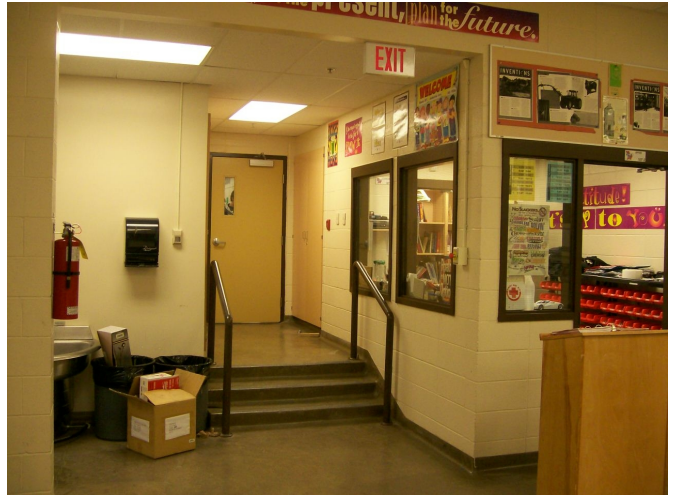
C2010 Stair Construction*- 1981 Section

A concrete stair in industrial arts classroom.

<u>Rating</u>	<u>Installed</u>	<u>Design Life</u>	<u>Updated</u>
5 - Good	1981	100	MAR-09

The stair in industrial arts classroom.

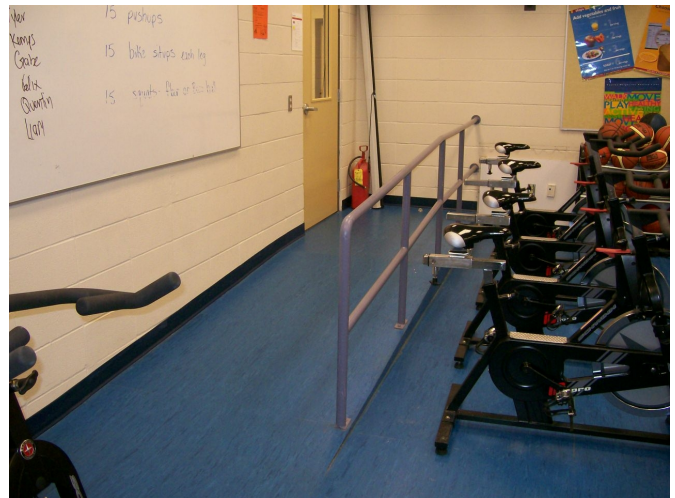
The corridor at the northwest entrance to the gymnasium was renovated to a wood ramp and it goes from the gymnasium level to the main floor.

<u>Rating</u>	<u>Installed</u>	<u>Design Life</u>	<u>Updated</u>
5 - Good	2006	100	MAR-09

The ramp in exercise room (CR 112).

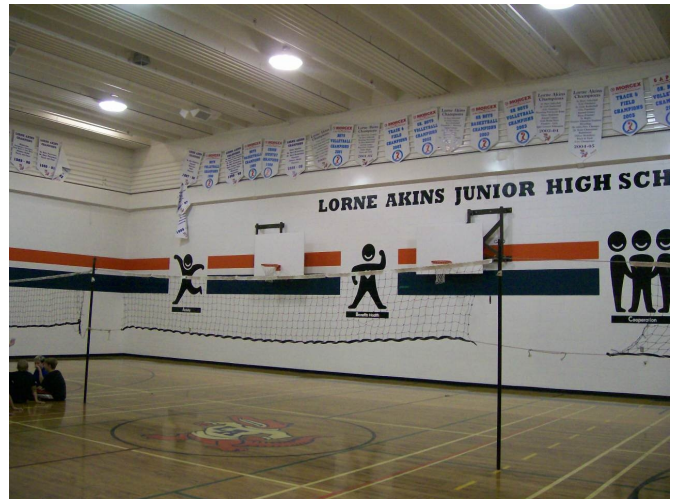
Metal sidings on the upper portion of 3 walls in the gymnasium.

<u>Rating</u>	<u>Installed</u>	<u>Design Life</u>	<u>Updated</u>
4 - Acceptable	1963	30	MAR-09

The metal sidings on the upper portion of the walls in the gymnasium.

Event: Replace metal sidings. (Approx. 25.00 sq.m.)

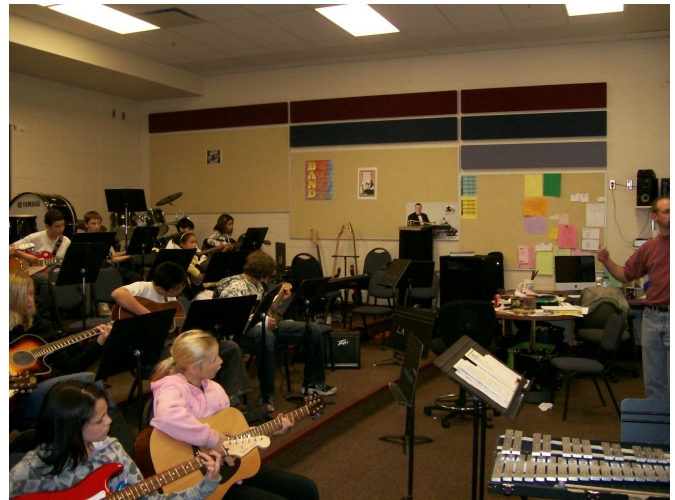
Acoustic wall panels on 2 walls in music room.

<u>Rating</u>	<u>Installed</u>	<u>Design Life</u>	<u>Updated</u>
5 - Good	2006	20	MAR-09

The acoustic wall panels above the tackboards on the wall of music room.

Event: Replace acoustic wall panels. (Approx. 10.00 sq.m.)

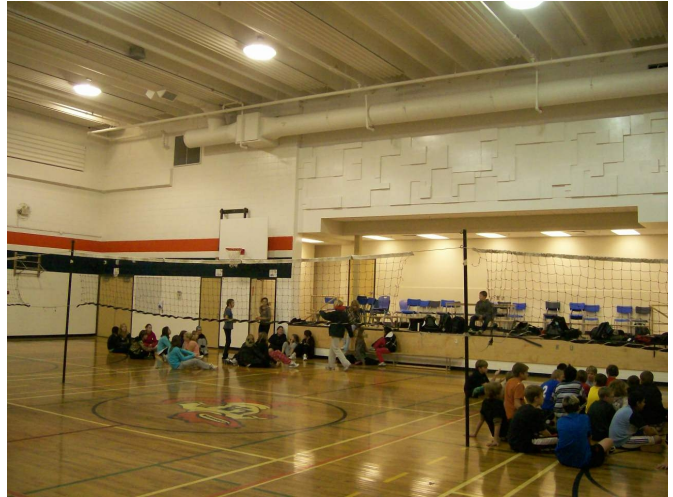
Metal siding on some areas of the precast concrete Tee ceiling in gymnasium.

<u>Rating</u>	<u>Installed</u>	<u>Design Life</u>	<u>Updated</u>
5 - Good	1963	0	MAR-09

Metal sidings on the ceiling of gymnasium.

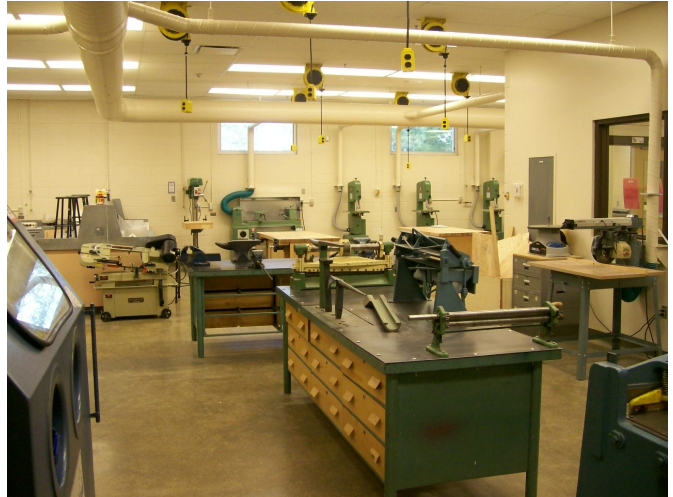
Wood working equipment, metal work equipment, welding equipment, equipment for ceramics & 1 kiln, computers & graphic equipment in industrial arts classroom.

<u>Rating</u>	<u>Installed</u>	<u>Design Life</u>	<u>Updated</u>
4 - Acceptable	2006	0	MAR-09

A partial view of the industrial arts classroom.

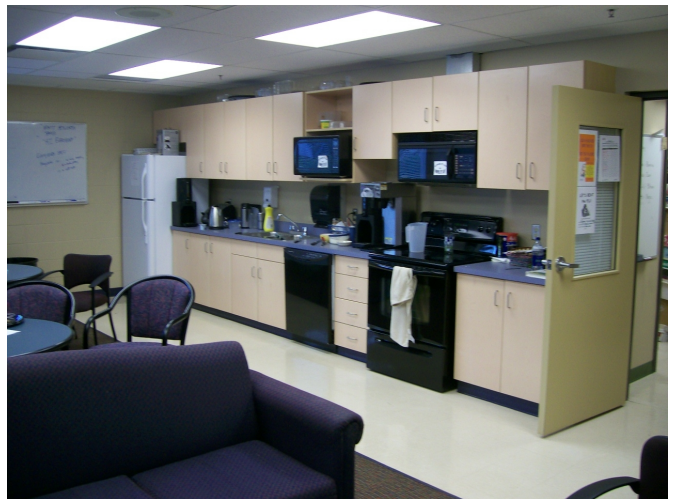
<u>Rating</u>	<u>Installed</u>	<u>Design Life</u>	<u>Updated</u>
5 - Good	2006	0	MAR-09

The kitchen in staff room.

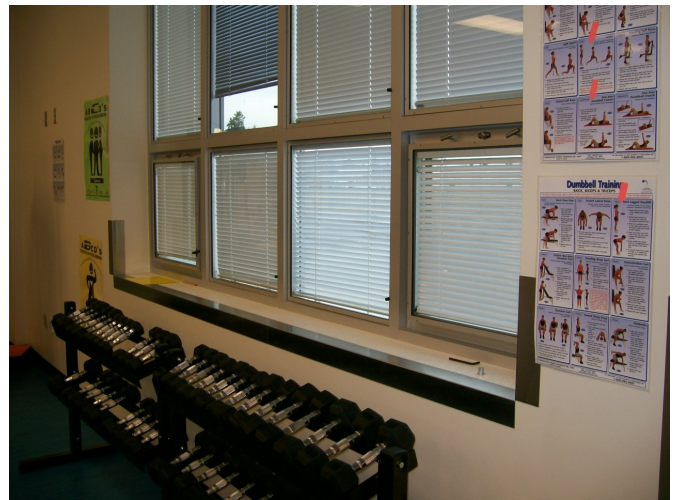
Venetian blinds throughout.

<u>Rating</u>	<u>Installed</u>	<u>Design Life</u>	<u>Updated</u>
5 - Good	2006	30	MAR-09

The exterior double glazed windows with integral blinds.

Event: **Replace venetian blinds.**

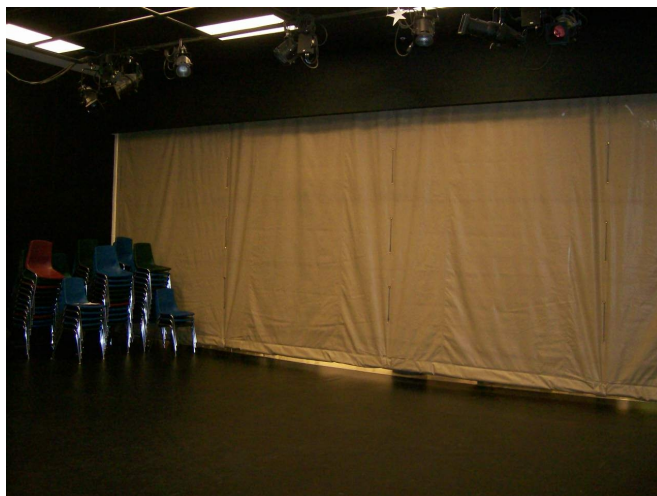
A ceiling-mounted curtain between drama room (ANC 132) and lunch room (LS 139).

<u>Rating</u>	<u>Installed</u>	<u>Design Life</u>	<u>Updated</u>
5 - Good	1981	30	MAR-09

The ceiling-mounted curtain between drama room and lunch room.

Event: Replace 1 ceiling-mounted curtain.

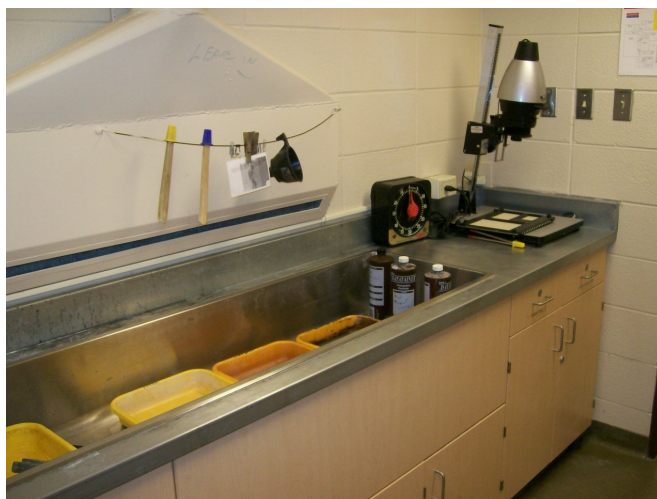
A dark room with dark room equipment in industrial arts classroom.

<u>Rating</u>	<u>Installed</u>	<u>Design Life</u>	<u>Updated</u>
5 - Good	2006	0	MAR-09

The dark room in industrial arts classroom.
